**MULTI-MEDIA COMPLIANCE EVALUATION INSPECTION
U.S. ENVIRONMENTAL PROTECTION AGENCY
REGION III
OFFICE OF ENFORCEMENT, COMPLIANCE, & ENVIRONMENTAL JUSTICE**

**American Zinc Recycling Corporation
(formerly Horsehead Corporation)
900 Delaware Ave
Palmerton, Pennsylvania 18071**

Inspection Dates: 14-18 May 2018

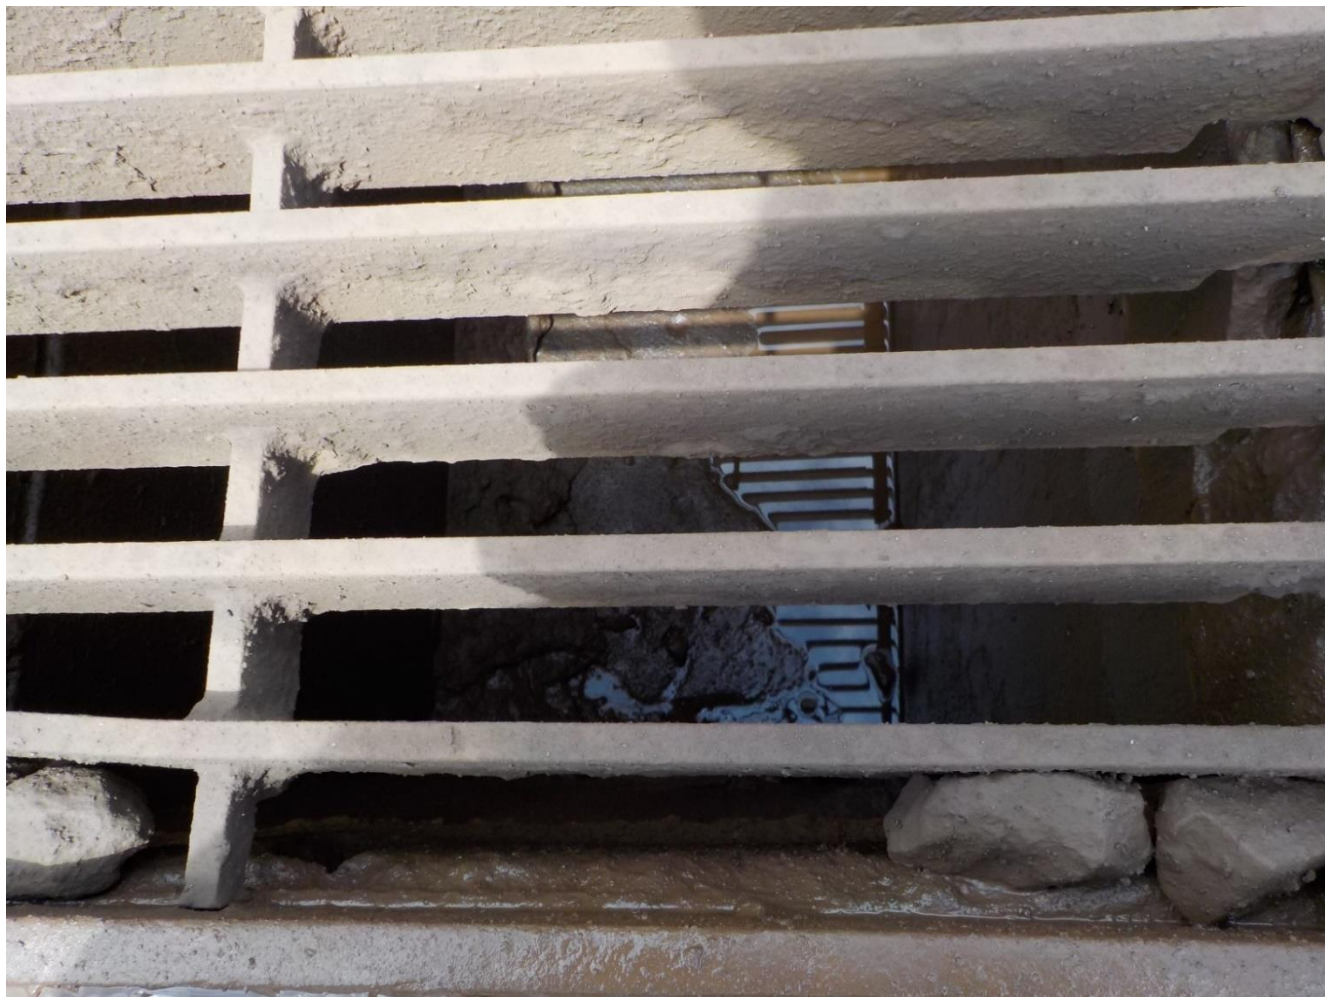
Photo 4. (DSCN0089) This photo, shows a portion of the interior of catch basin #2, located southeast of the Building 608 truck entrance, offset from storm sewer lateral 5. Note the deposits of fine-grained, brown material in the bottom of the catch basin.

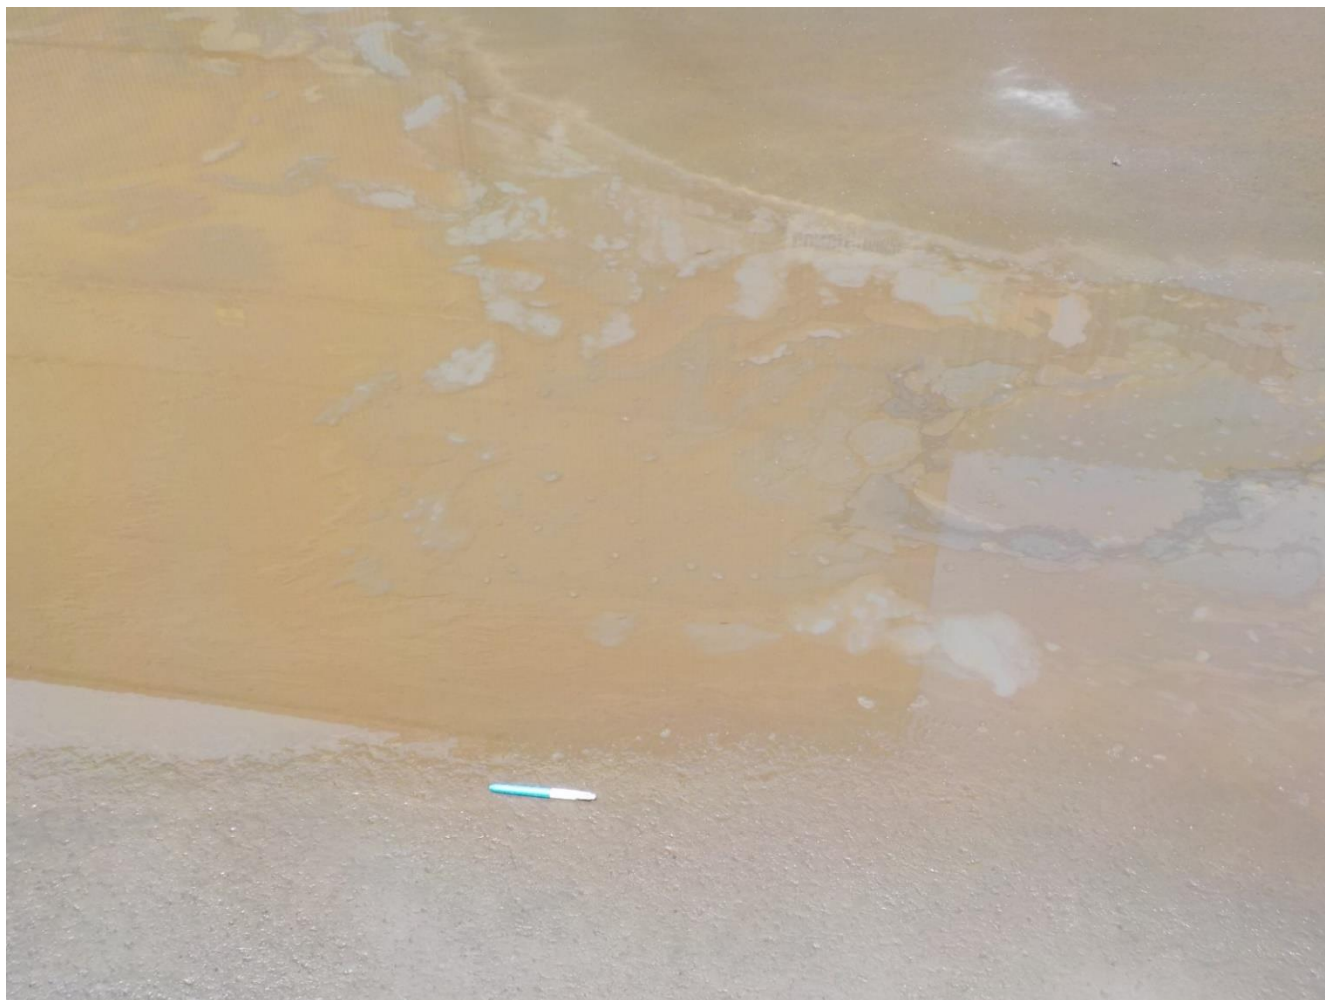
Photo 8. (DSCN0095) This photo, taken from a point along the southern perimeter of the Facility, looks northward towards the truck entrance on the south side of Building 608. A large puddle of storm water is visible on the paved road approximately 3-5 meters from the roll door. See also Photo 9 for a close-up view of water color, clarity, and suspended sediment.

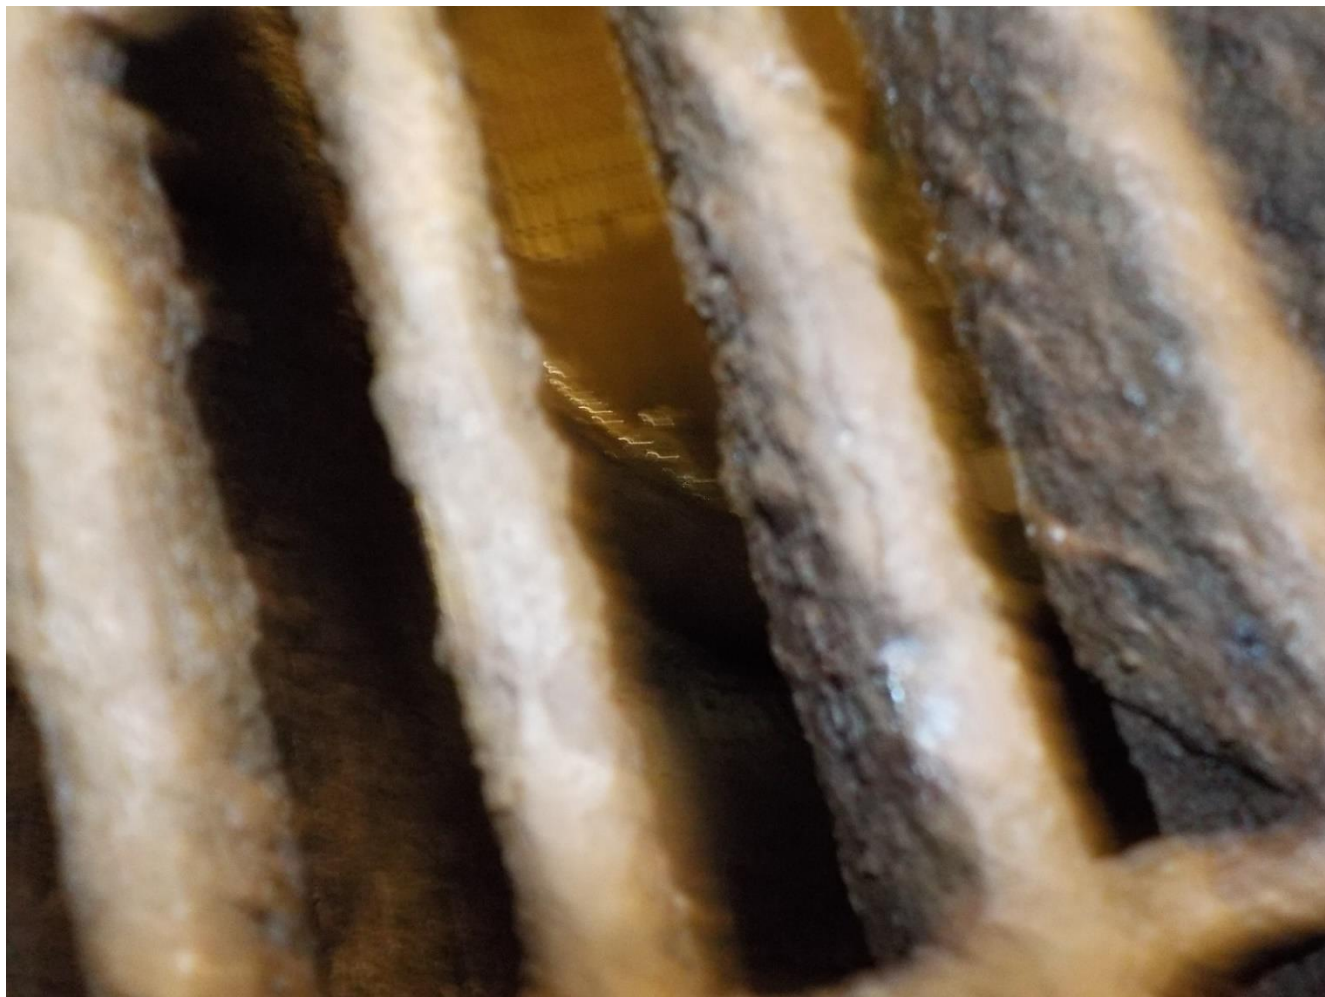
Photo 30. (DSCN0179) This photo shows the top of the concrete pit that contains the round, open-top holding tank for dirty wash water from the truck wash bays (Building 624). Appurtenances visible above the metal grates covering the pit include an agitator, the inflow pipe, and a pump that moves the dirty wash water to the water cannon in Building 608. See also Photo 31.

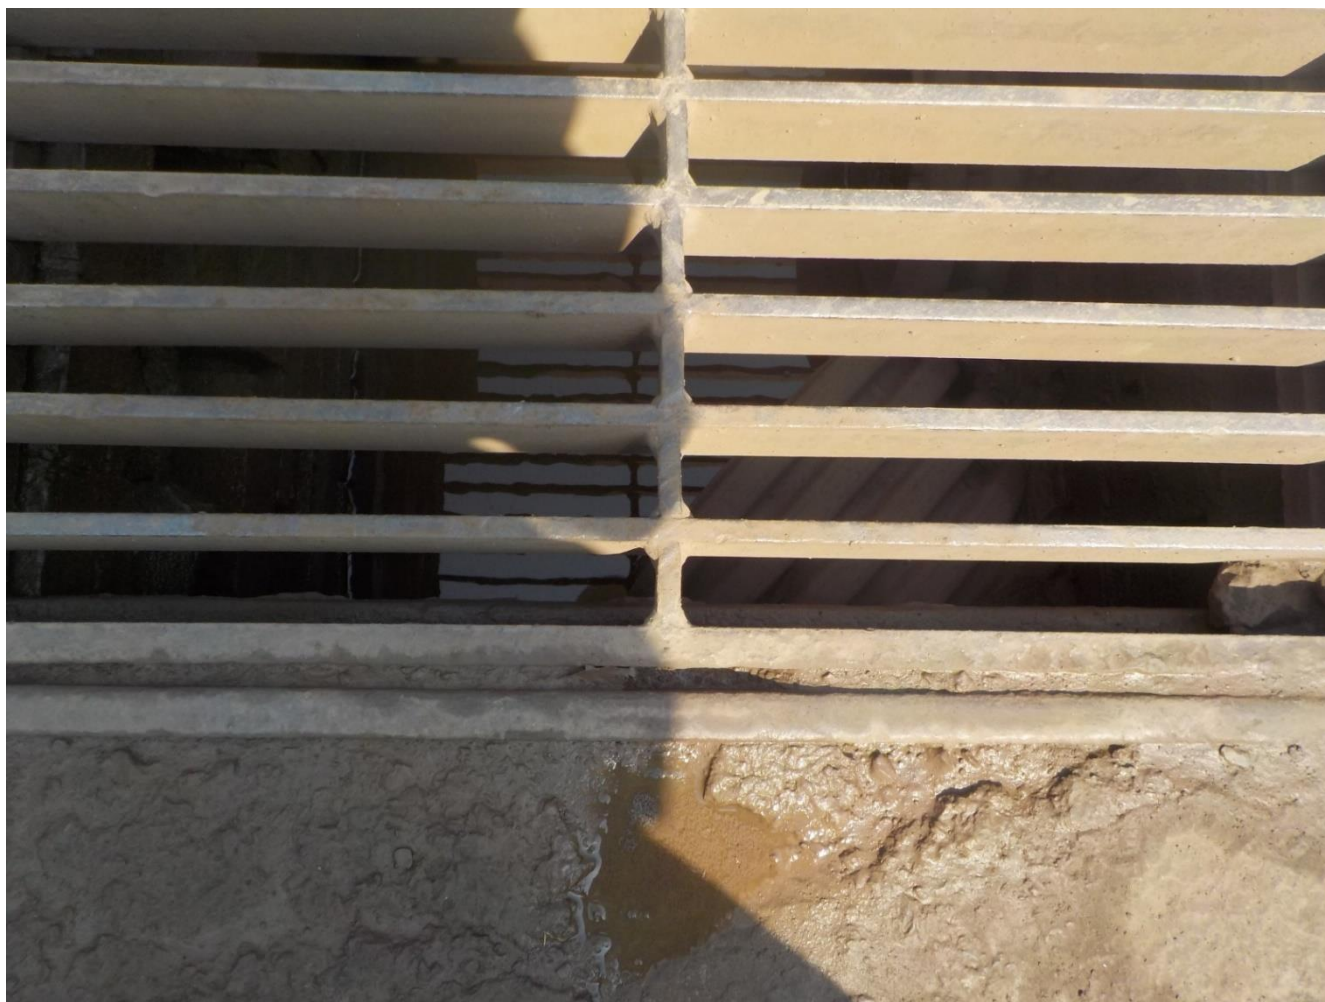
Photo 41. (DSCN0212) This photo, taken in the paved area between Buildings 608/624 and the Lime bunker, looks northward and shows a close-up view of catch basin 15. Note the deposits of wet, brown, fine-grained material around the edges of the inlet. See also Photo 42 for an interior view of the catch basin.

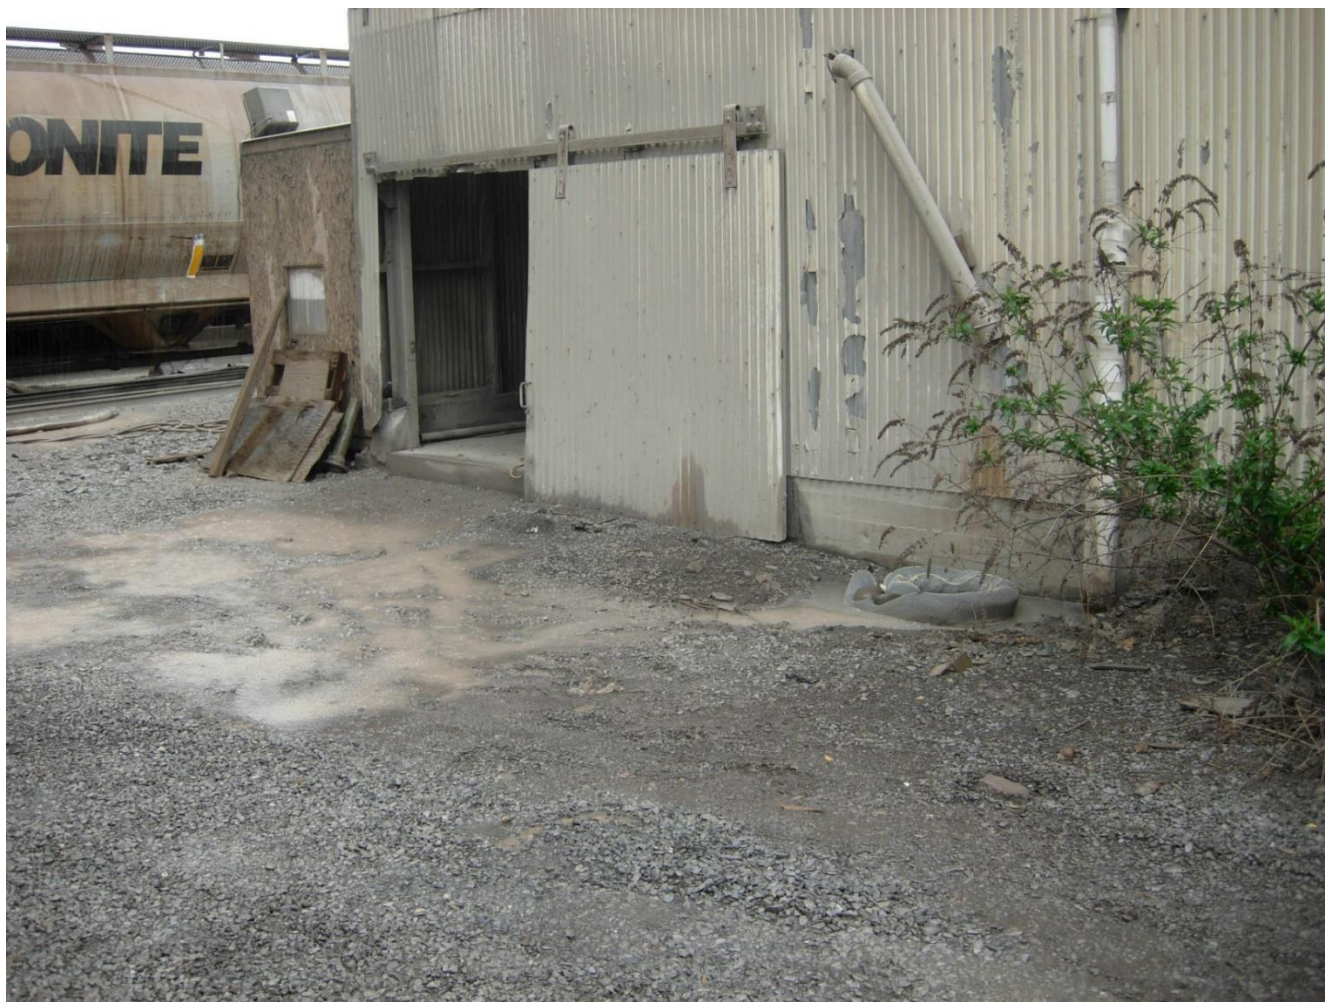
Photo 47. (DSCN0361) This photo, taken in the paved area between buildings 608/624 and the Lime bunker during rain on 16 May, 2018, looks northward towards catch basin 18. Note the flow of brown storm water into the inlet from the paved areas in between buildings 608/624 and the Lime Bunker. See also Photos 35, 45, and 46.

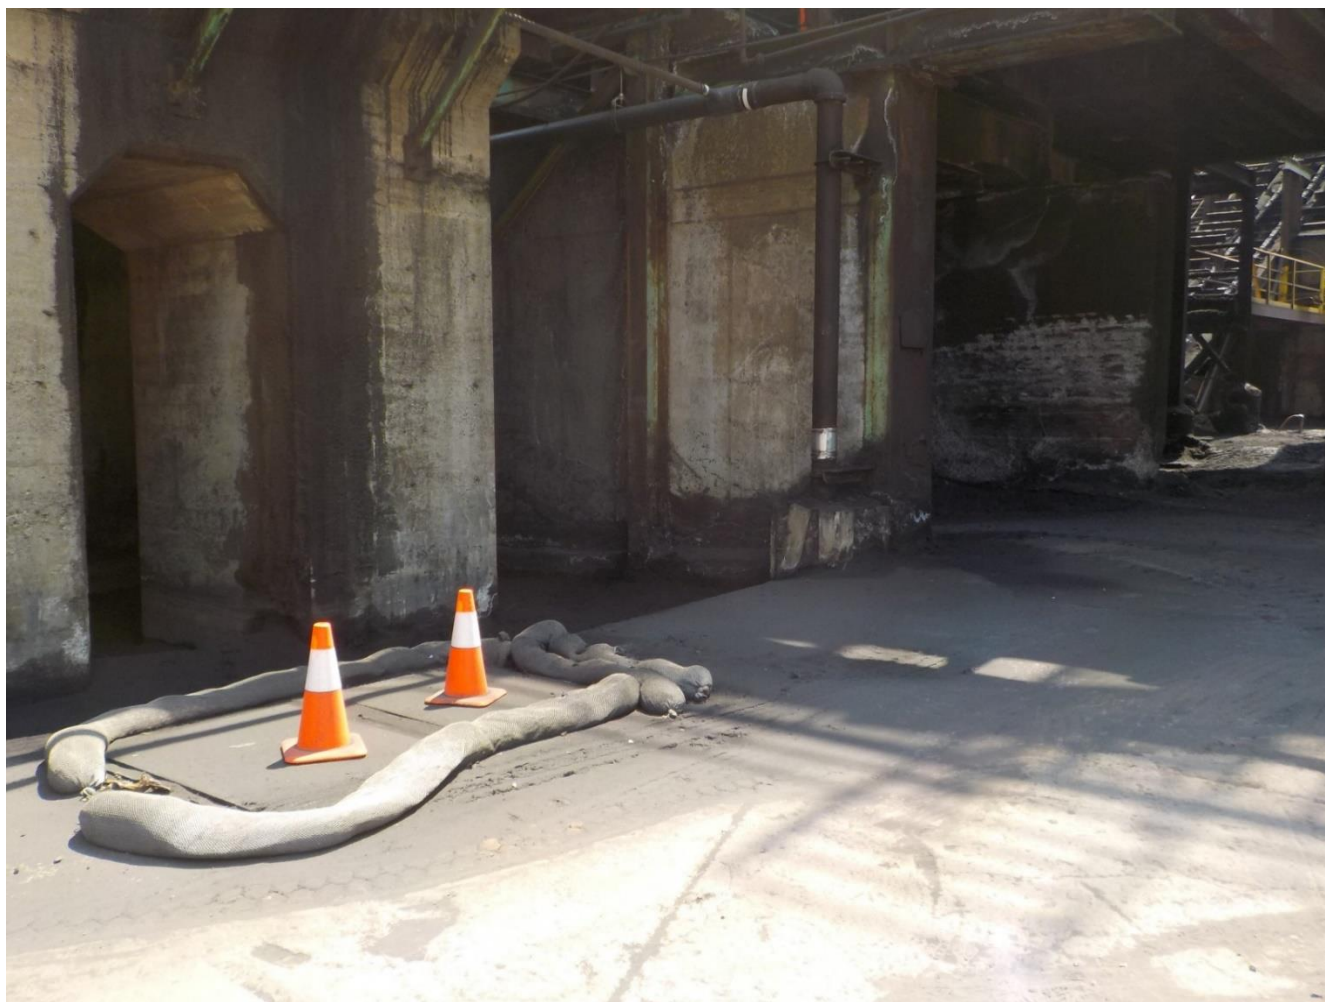
Photo 49. (DSCN0276; NIKON COOLPIX P4) This photo shows a close-up view of the inlet to catch basin 16, located just outside the “number 9 fan room.” Note the absorbent sock held in place by two rocks and the flooding of the inlet. See also Photo 48.

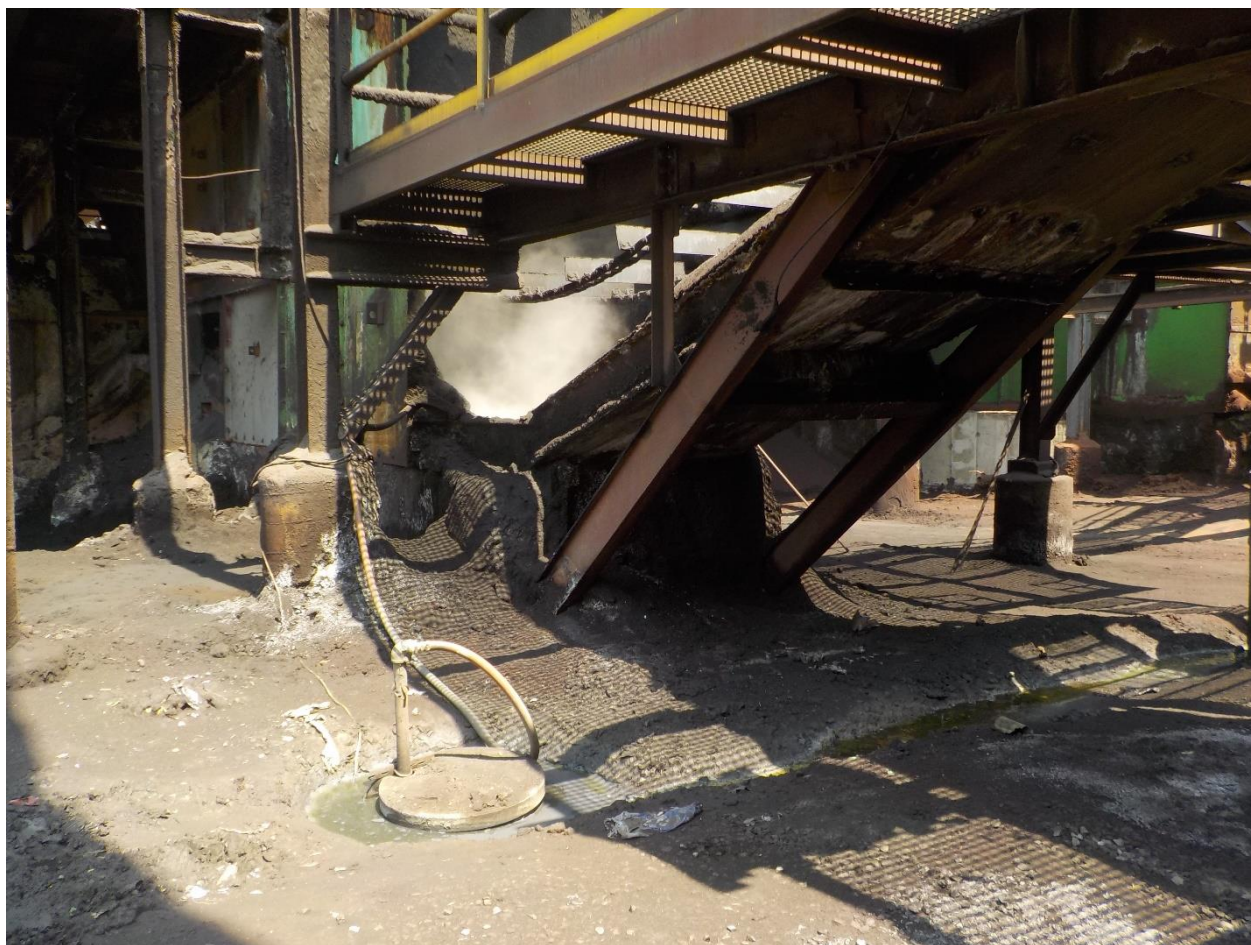
Photo 53. (DSCN0354) This photo, taken during rain on 16 May, 2018, shows another view of catch basin 5, immediately adjacent to the concrete support structure at the lower end of Kiln 2. Note, the pool of brown, co-mingled storm water and quench water runoff that has accumulated below the concrete arches.

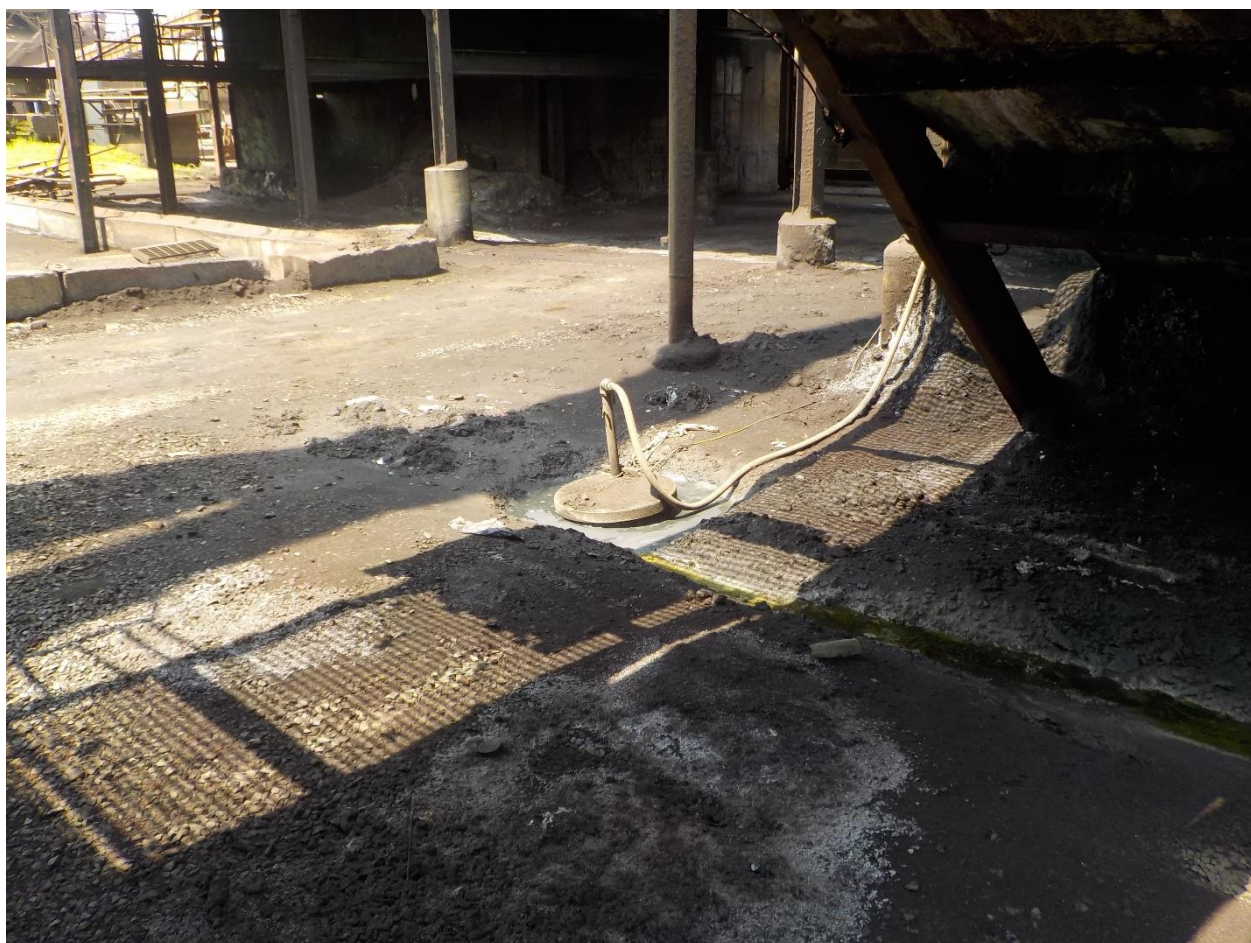
Photo 57. (DSCN0240) This photo, taken from the same location as Photo 56, looks right (northward) from the open end of the IRM bunker for Kiln 2. Note, the dark yellow IRM quench water on the ground pools and drains northward via shallow swale, to the earthen sump shown in Photo 55. The submersible pump and flexible hose that, according to Mr. Falko, returns the quench water to the quench tank, is visible in the background.

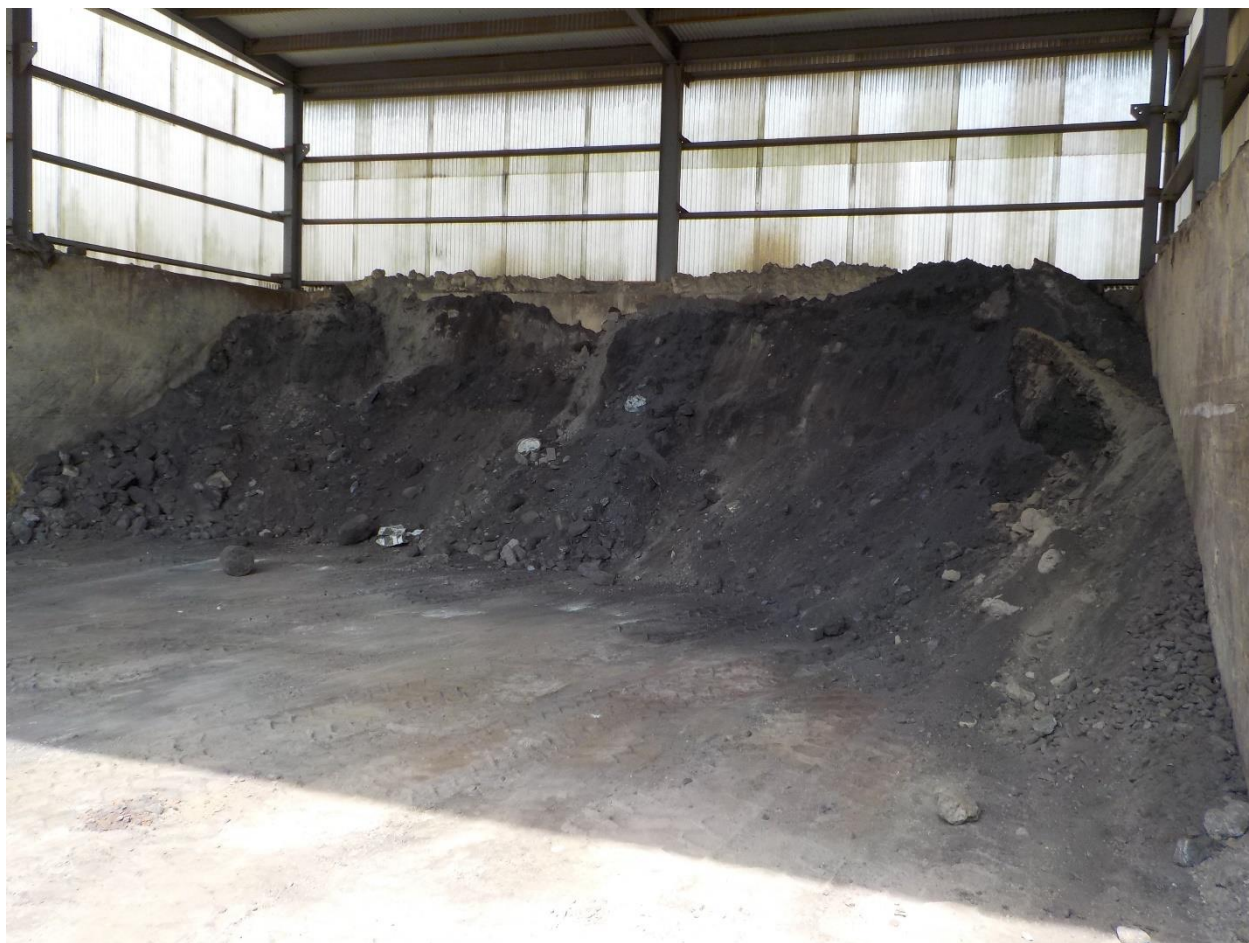
Photo 79. (DSCN0252) This photo looks eastward at the Lime bunker. Note, a pile of kiln rubble (damaged kiln brick), a D006/D008 hazardous waste, is present inside the bunker. See also Photos 33, 35, and 80.

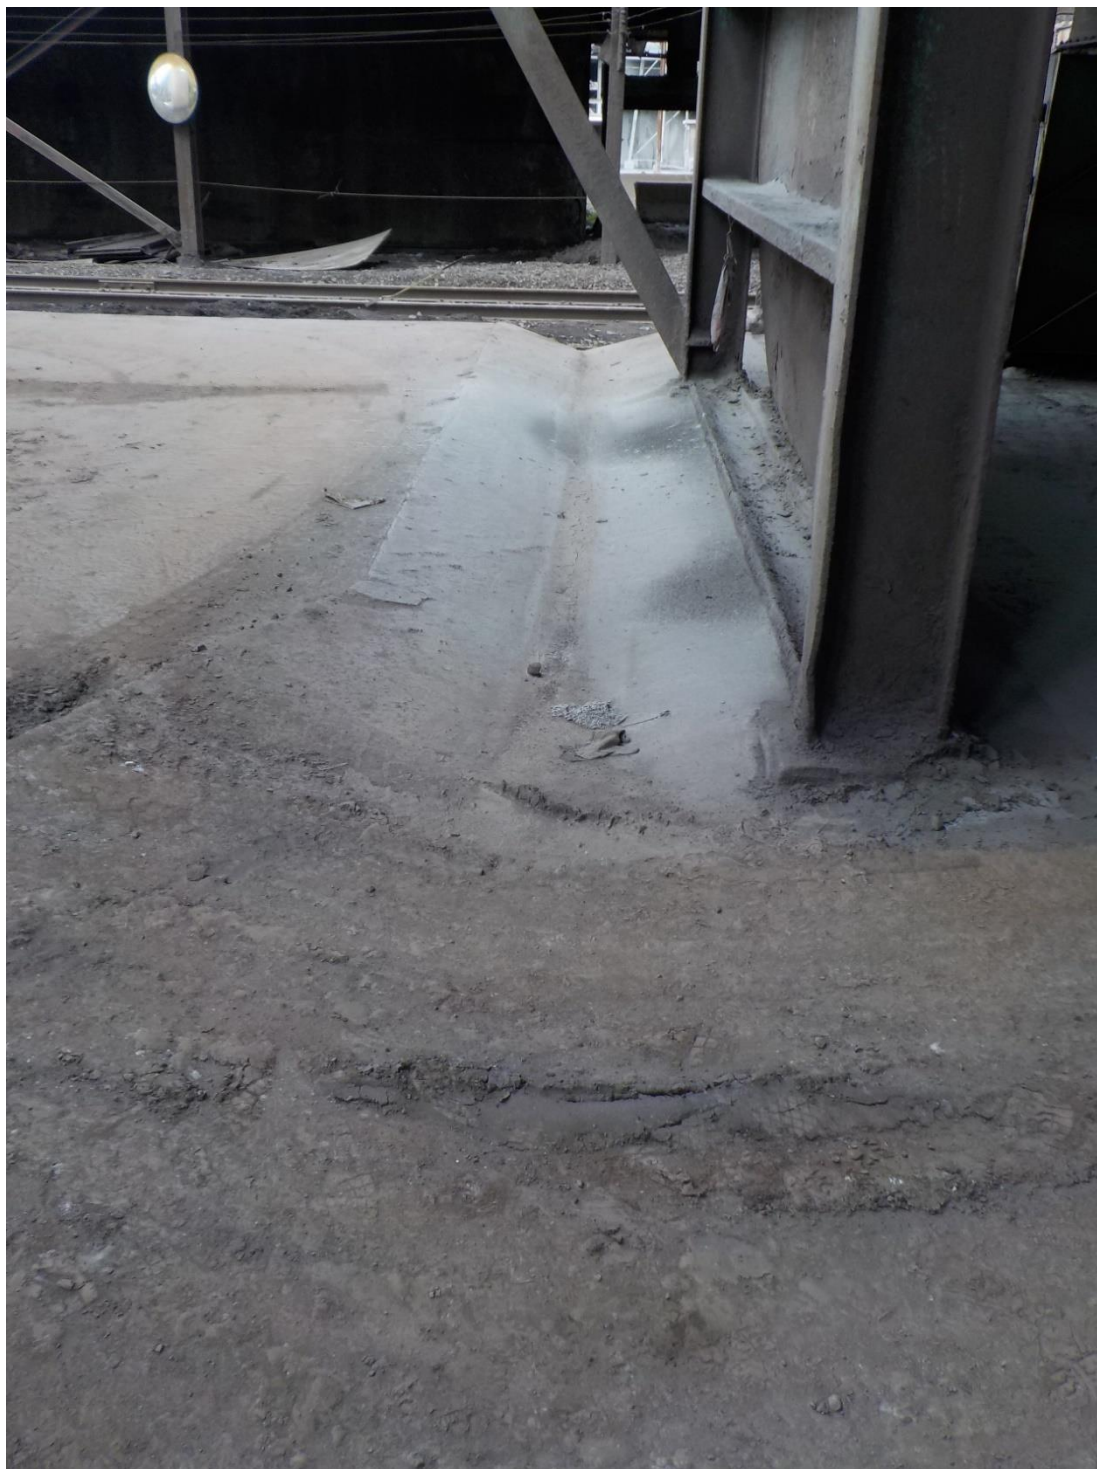
Photo 82. (DSCN0269) This photo, taken during dry weather on 15 May, 2018, from a position between Kiln 1 and Kiln 2, looks northward along a concrete drainage swale towards the railroad bed immediately north of the kilns. This is the first in a series of photos (Photos 82-85 inclusive) that traces this swale north to the railroad bed. Note the swale is partially filled with light brown to black sedimentary material. See Photo 86 for a comparison to wet weather conditions at the same location.

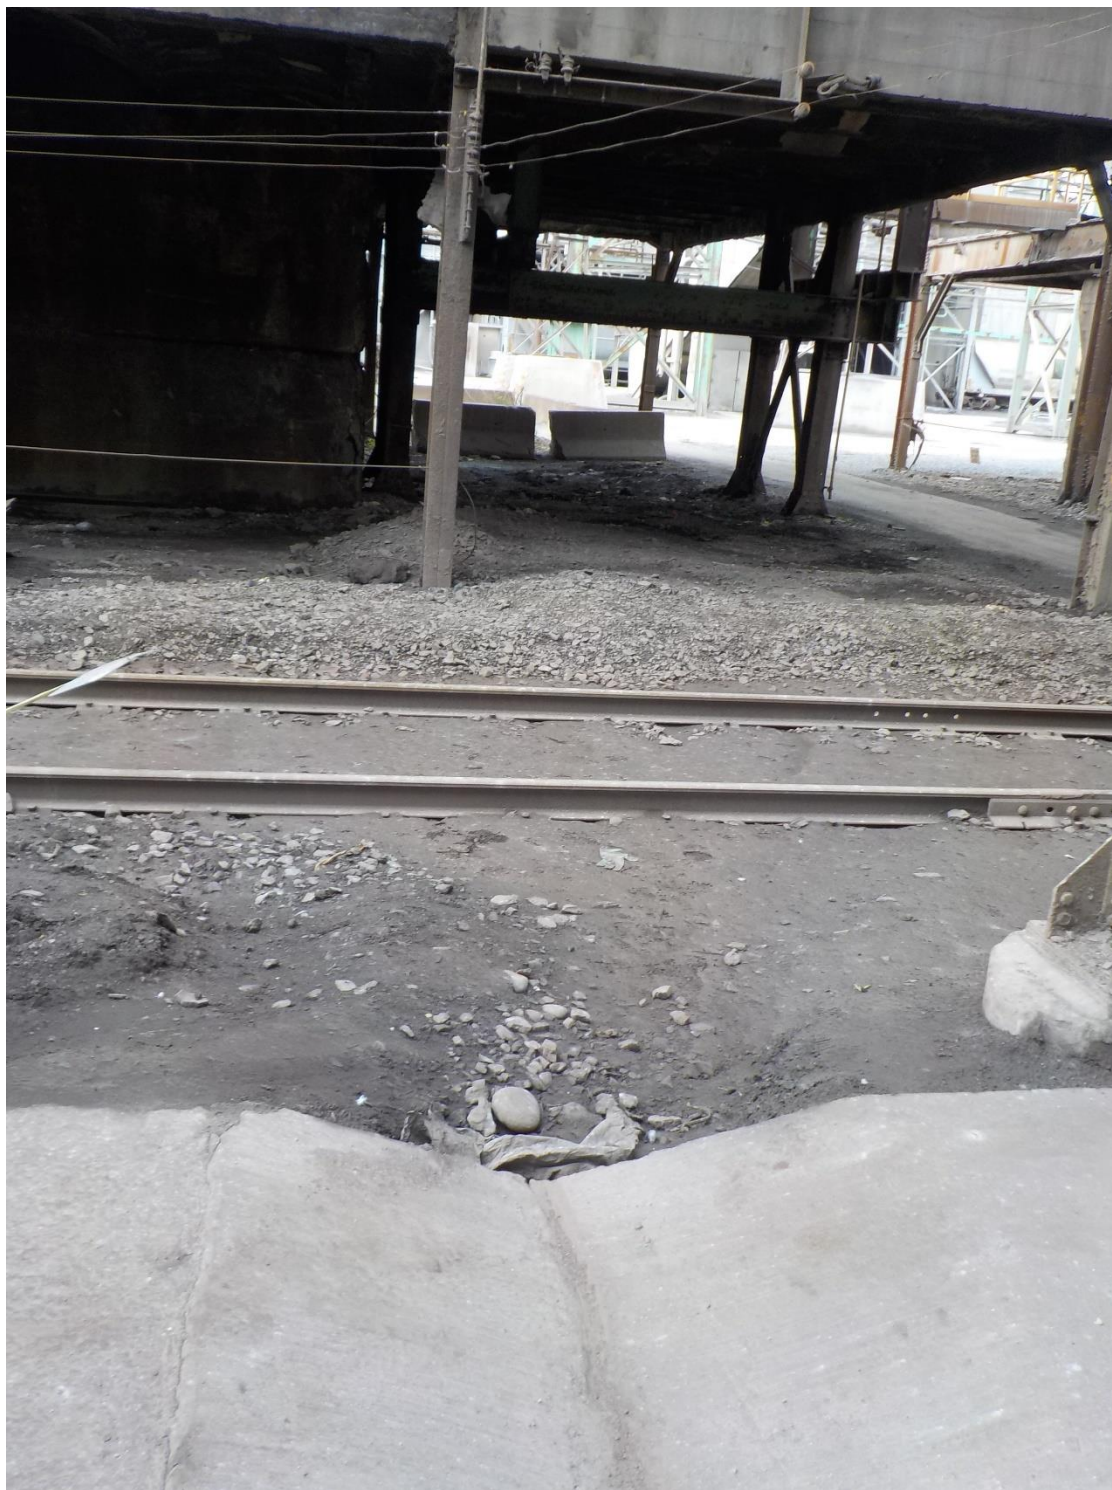
Photo 83. (DSCN0270) This photo, taken during dry weather on 15 May, 2018, is the second in a series of photos (Photos 82-85 inclusive) that traces a concrete drainage swale northward between Kilns 1 and 2. Note the presence of sedimentary material in the swale. See Photo 87 for a comparison to wet weather conditions at the same location.

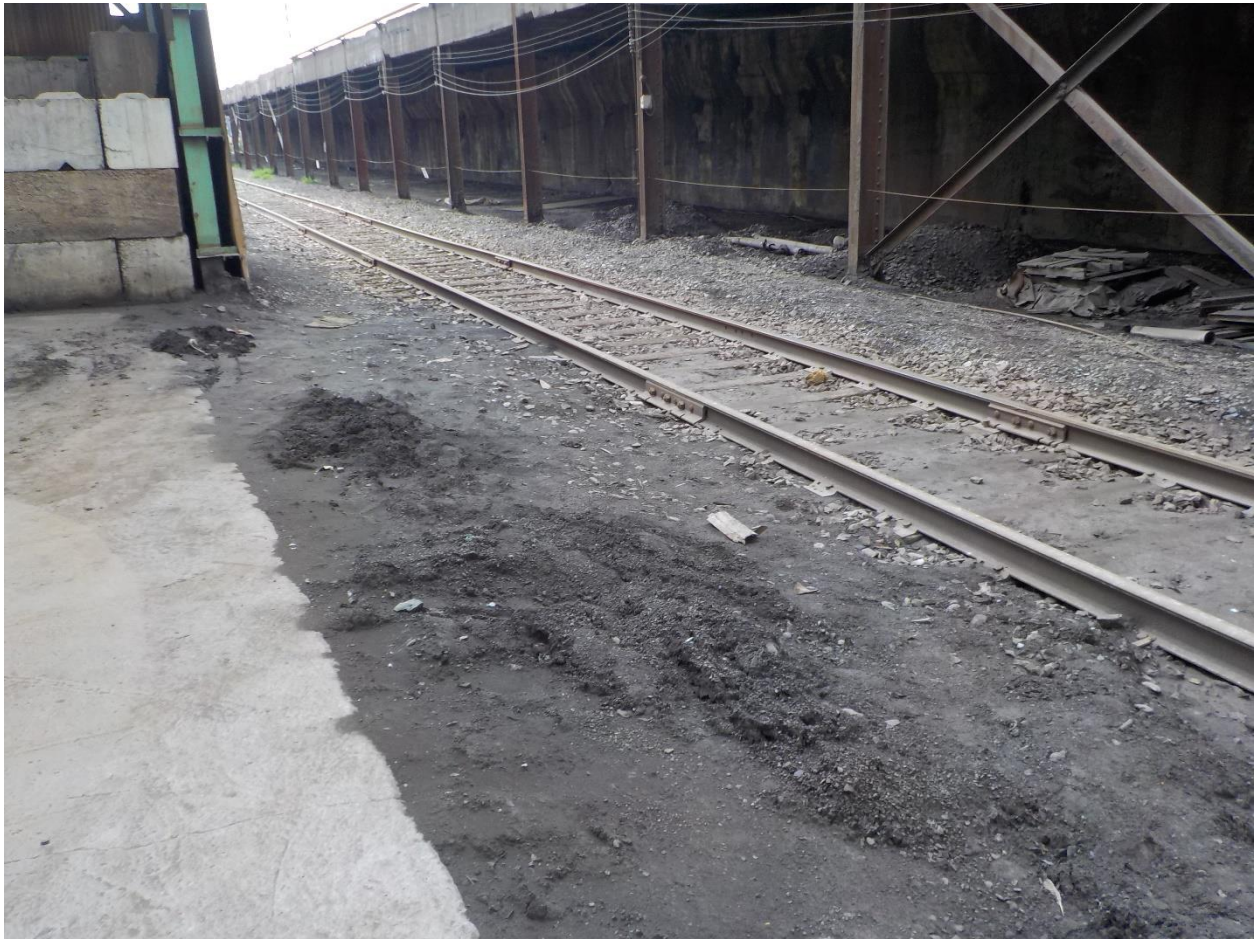
Photo 84. (DSCN0272) This photo, taken during dry weather on 15 May, 2018, is the third in a series of photos (Photos 82-85 inclusive) that traces a concrete drainage swale northward between Kilns 1 and 2. Note the presence of sedimentary material in the swale. See Photo 88 for a comparison to wet weather conditions at the same location.

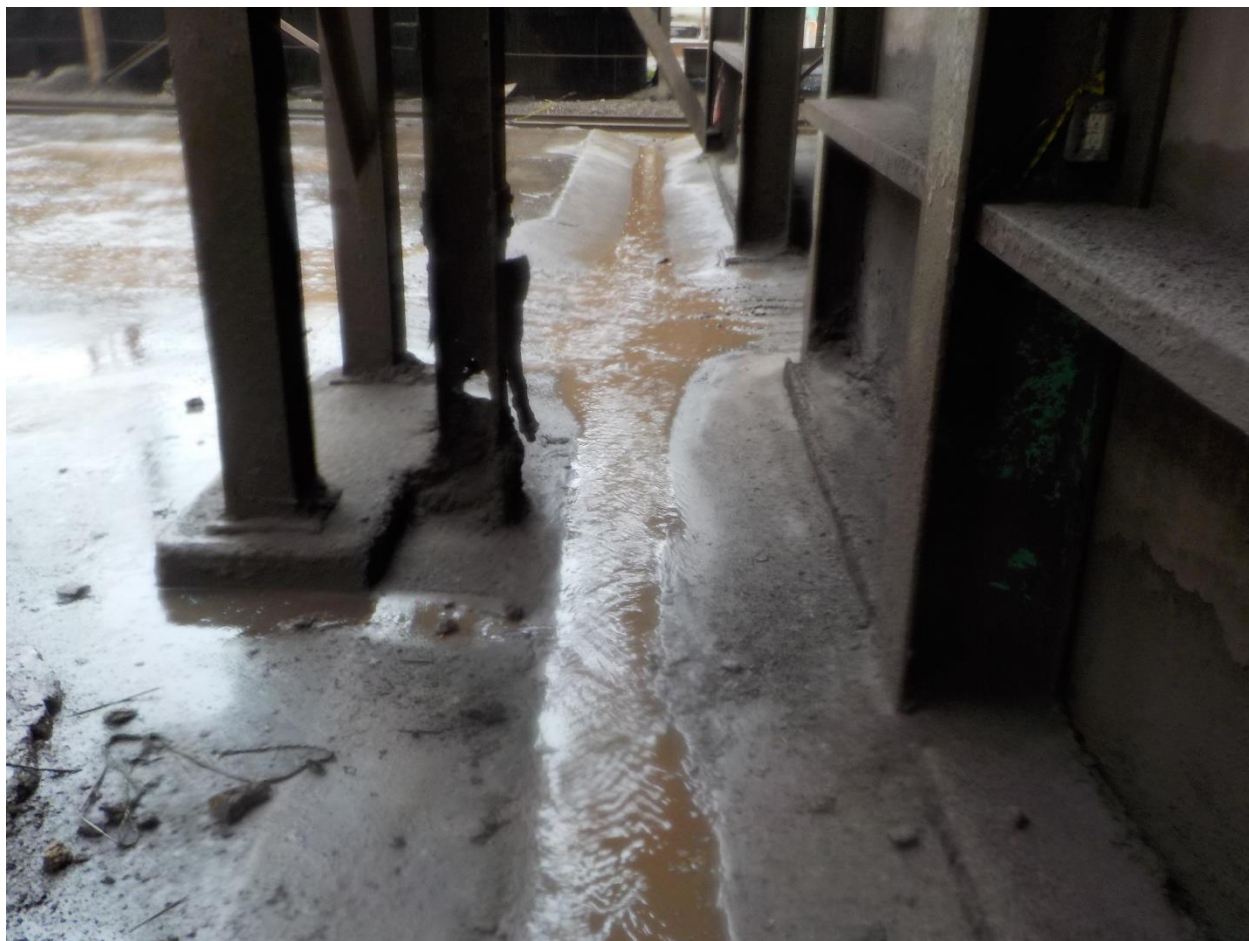
Photo 86. (DSCN0333) This photo, taken during rainy weather on 16 May, 2018, is the first in a series of photos (Photos 86-89 inclusive) that traces the concrete drainage swale northward between Kilns 1 and 2. Note the storm water, discolored brown, flowing northward to the railroad bed. See Photo 82 for a comparison to dry weather conditions at the same location.

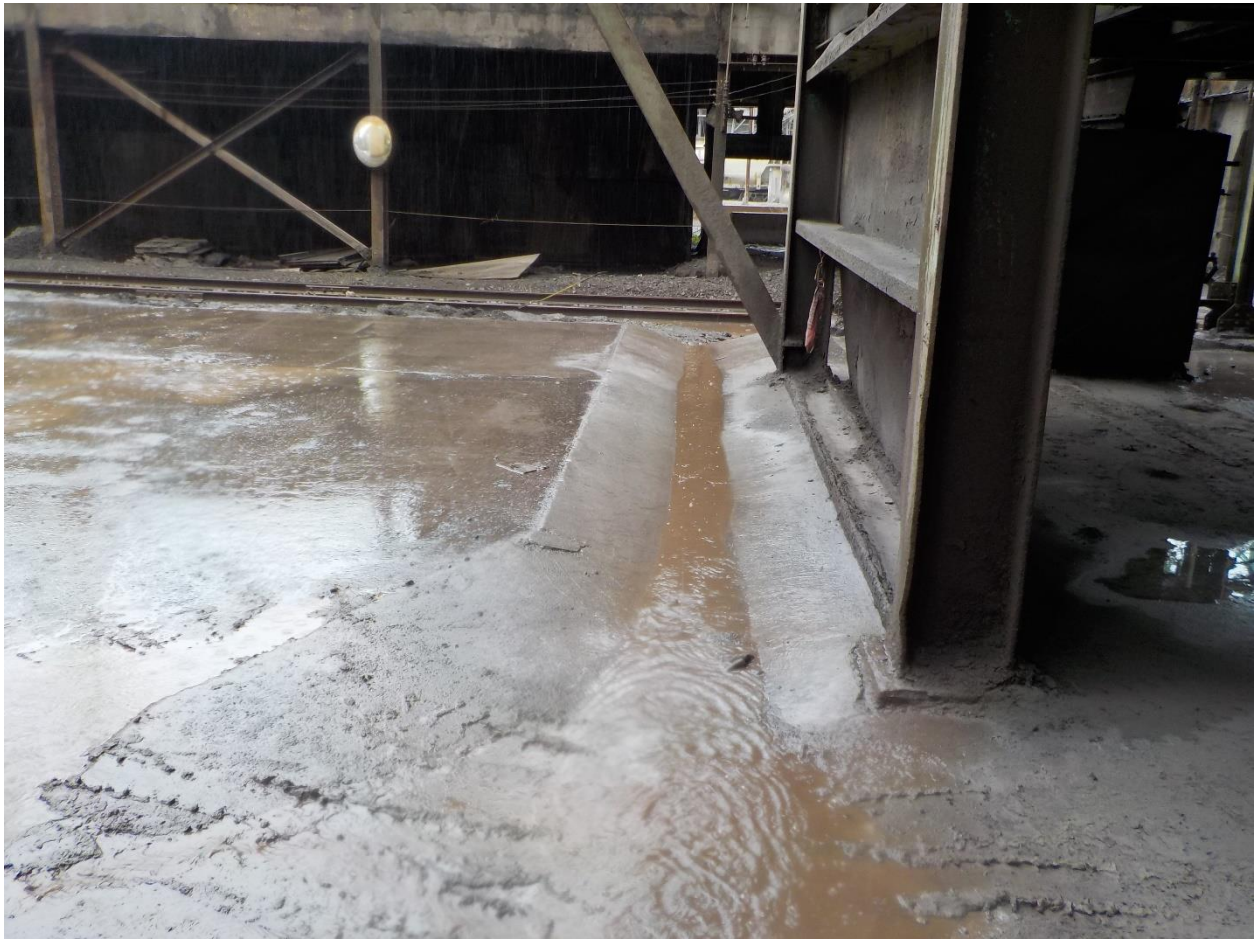
Photo 87. (DSCN0334) This photo, taken during rainy weather on 16 May, 2018, is the second in a series of photos (Photos 86-89 inclusive) that traces the concrete drainage swale northward between Kilns 1 and 2. Note the storm water, discolored brown, flowing northward to the railroad bed. See Photo 83 for a comparison to dry weather conditions at the same location.

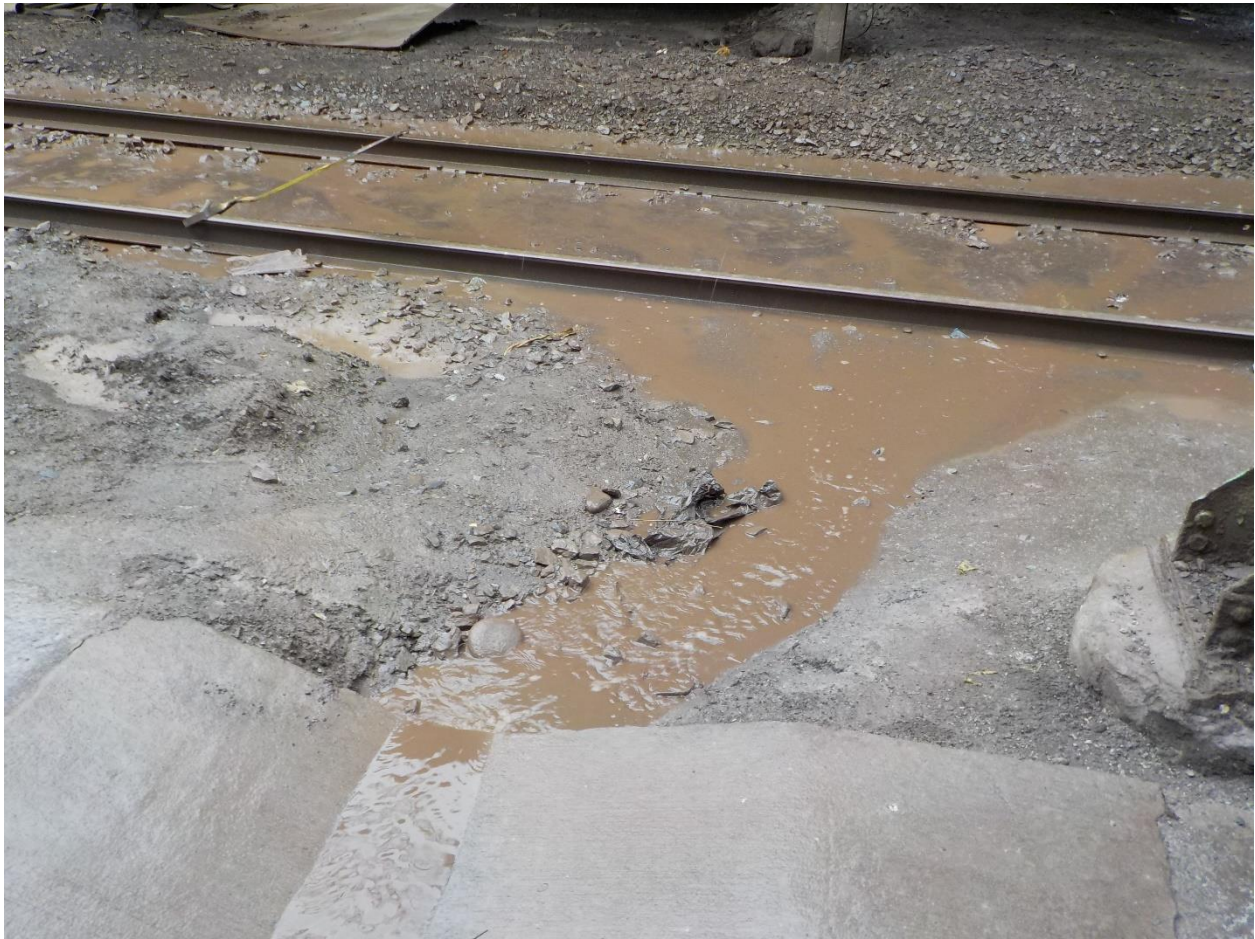
Photo 88. (DSCN0336) This photo, taken during rainy weather on 16 May, 2018, is the third in a series of photos (Photos 86-89 inclusive) that traces a concrete drainage swale northward between Kilns 1 and 2. Note the presence of storm water discolored brown, and sedimentary material in the swale. See also Photo 84 for a comparison to dry weather conditions at the same location.

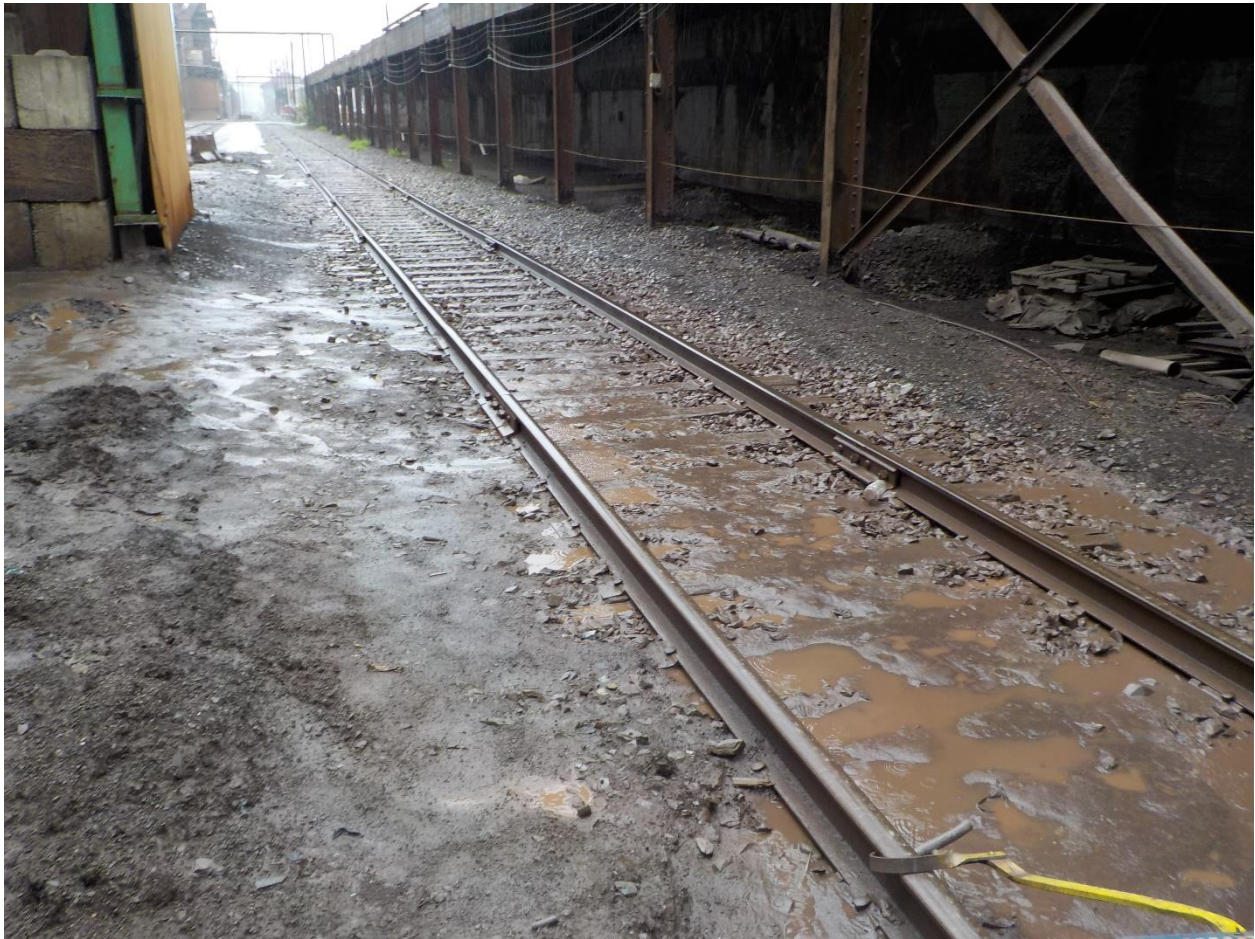
Photo 89. (DSCN0338) This photo, taken during rainy weather on 16 May, 2018, is the fourth and final in a series of photos (Photos 86-89 inclusive) that traces a concrete drainage swale northward between Kilns 1 and 2. Here, the camera pans left to view westward down the railroad tracks. Note the presence of sedimentary material on the railroad bed, clogging the gravel of the railroad bed, and pools of brown, sediment-laden storm water. Note also the black, granular or sandy material present on the north side of the railroad bed. See also Photos 85 for a comparison to dry weather conditions at the same location.
